UNITED STATES ENVIRONMENTAL PROTECTION AGENCY

Re: Notice of Violation  
RCRA Compliance Evaluation Inspection  
Multicircuits Inc.  
EPA I.D. No.: WID988580072

**Attachment A**  
**Photographs for Multicircuits RCRA CEI**  
**WID 988 580 072**  
**February 12, 2013**

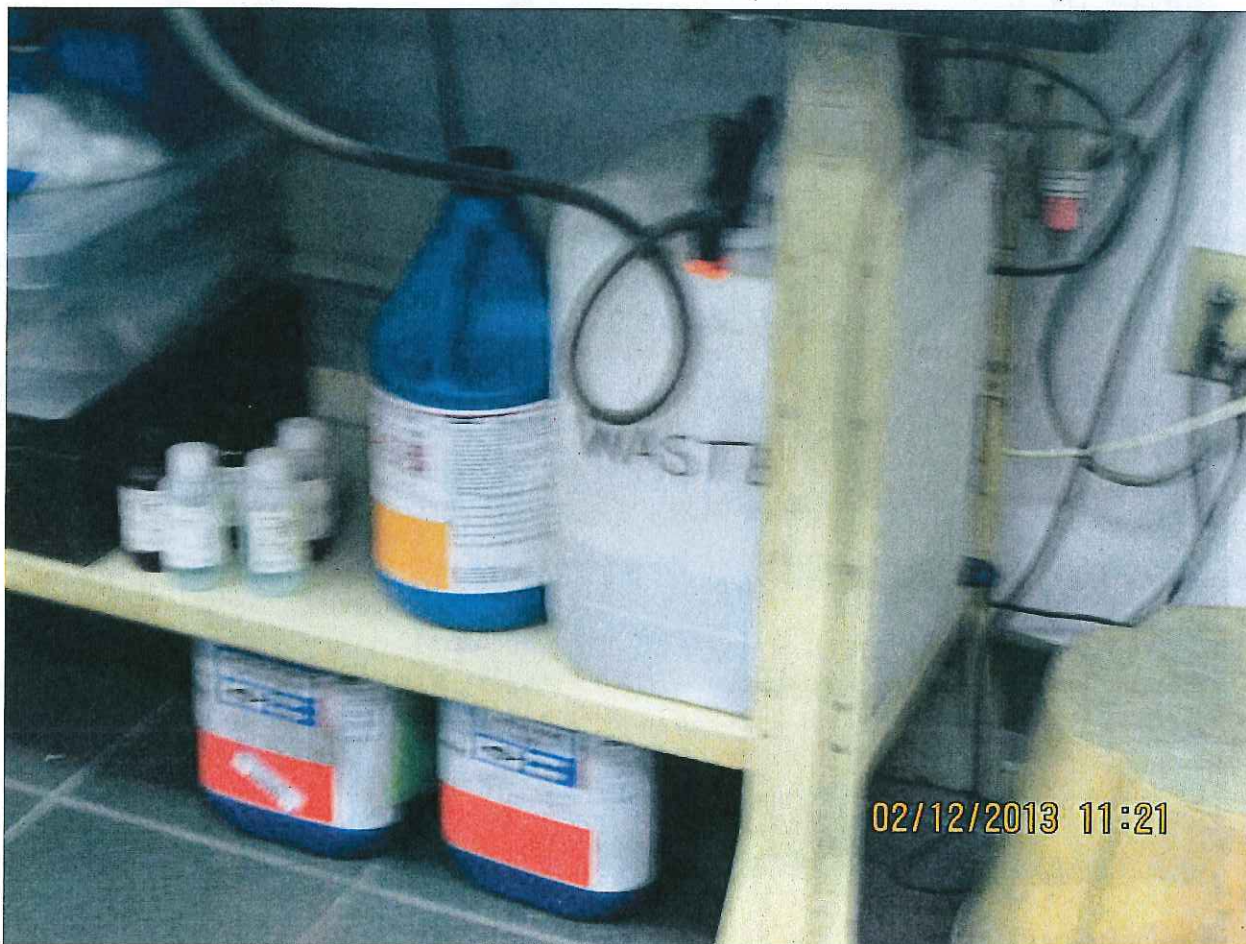
Photograph: # 2

During the inspection of the Laboratory Area, the inspector observed a 5 gallon container marked "waste." The facility representative stated that the "waste" is considered to be nonhazardous based on generator knowledge. Supporting documentation for the nonhazardous waste was not provided to the inspector. In using generator knowledge, a determination must be documented especially when the determination of the waste is not hazardous. Multicircuits, therefore, violated the above-referenced generator requirements.

container. See Photograph# 2. Mr. Kemper stated that the waste that was stored in the 5-gallon container was determined to be non-hazardous based on process knowledge. No hazardous waste determination documentation was provided at the time of the inspection. The Inspectors were then escorted to the Electroless Plating Area. At the Electroless Plating Area, Inspector Dabner observed two unmarked 55-gallon plastic drums. Pictures were taken of the unmarked 55-gallon drums. See Photographs#3 and #4. The facility representative informed the inspectors that the substance contained in the two 55-gallon drums were determined to be non-hazardous based on process knowledge. After inspecting the Electroless Plating Area, the inspection moved to the Electrolyte Tin Processing Area. Inspector Dabner observed one unmarked and unlabeled 55-gallon drum. Pictures were taken of the unmarked and unlabeled 55-gallon drum. See Photographs#5 and #6. Mr. Kemper explained the unmarked drum contained spent solder dross from the Soldering Process. He also informed the Inspectors that the spent dross generated from print circuit board manufacturing is considered to be by-product and is reclaimed and not managed as hazardous waste.

Description: 5 gallon container located in the Laboratory Area marked as "waste"

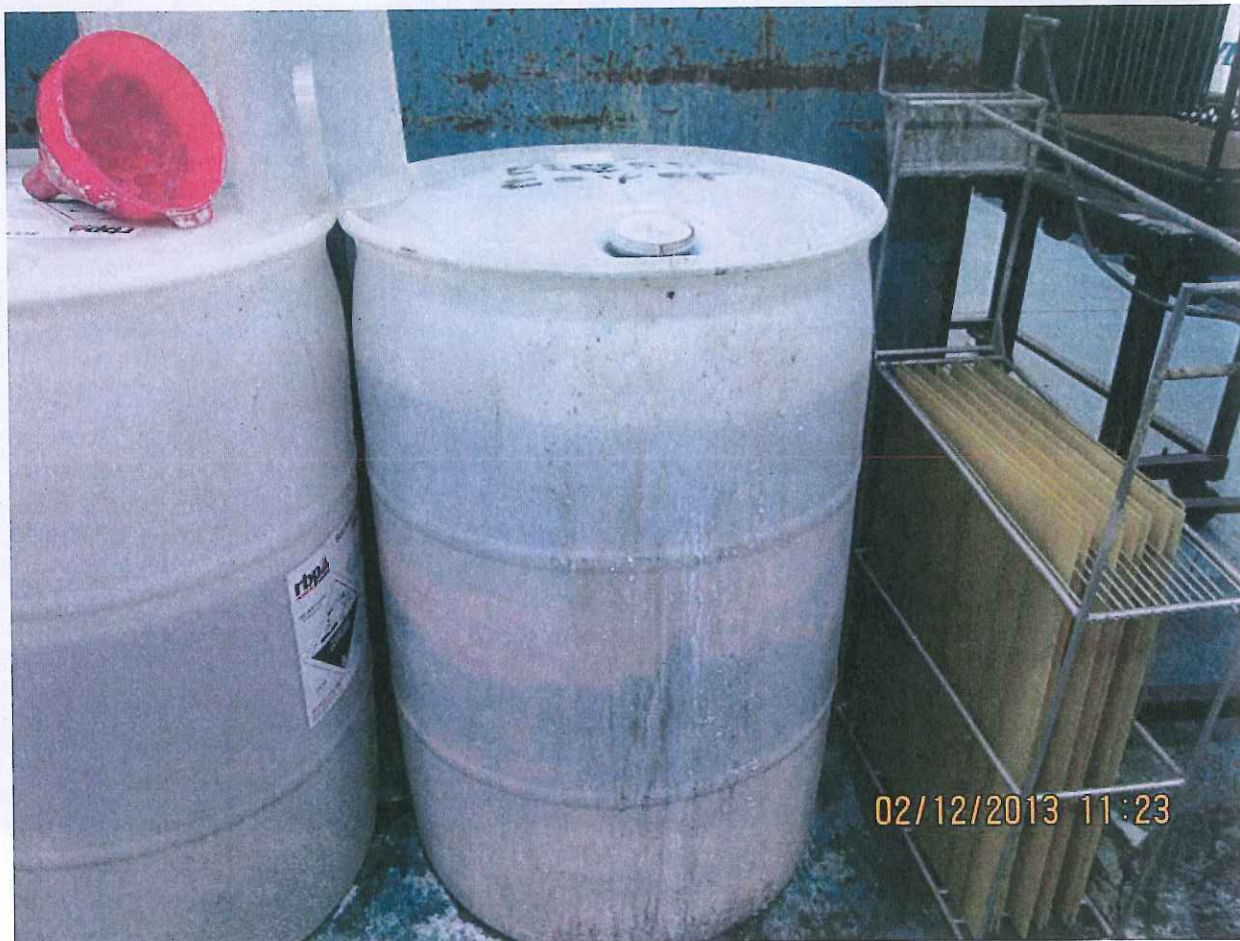
Photograph: #3

Description: Two unmarked plastic 55 gallon drums located in the wet area of the Electroless Plating Area

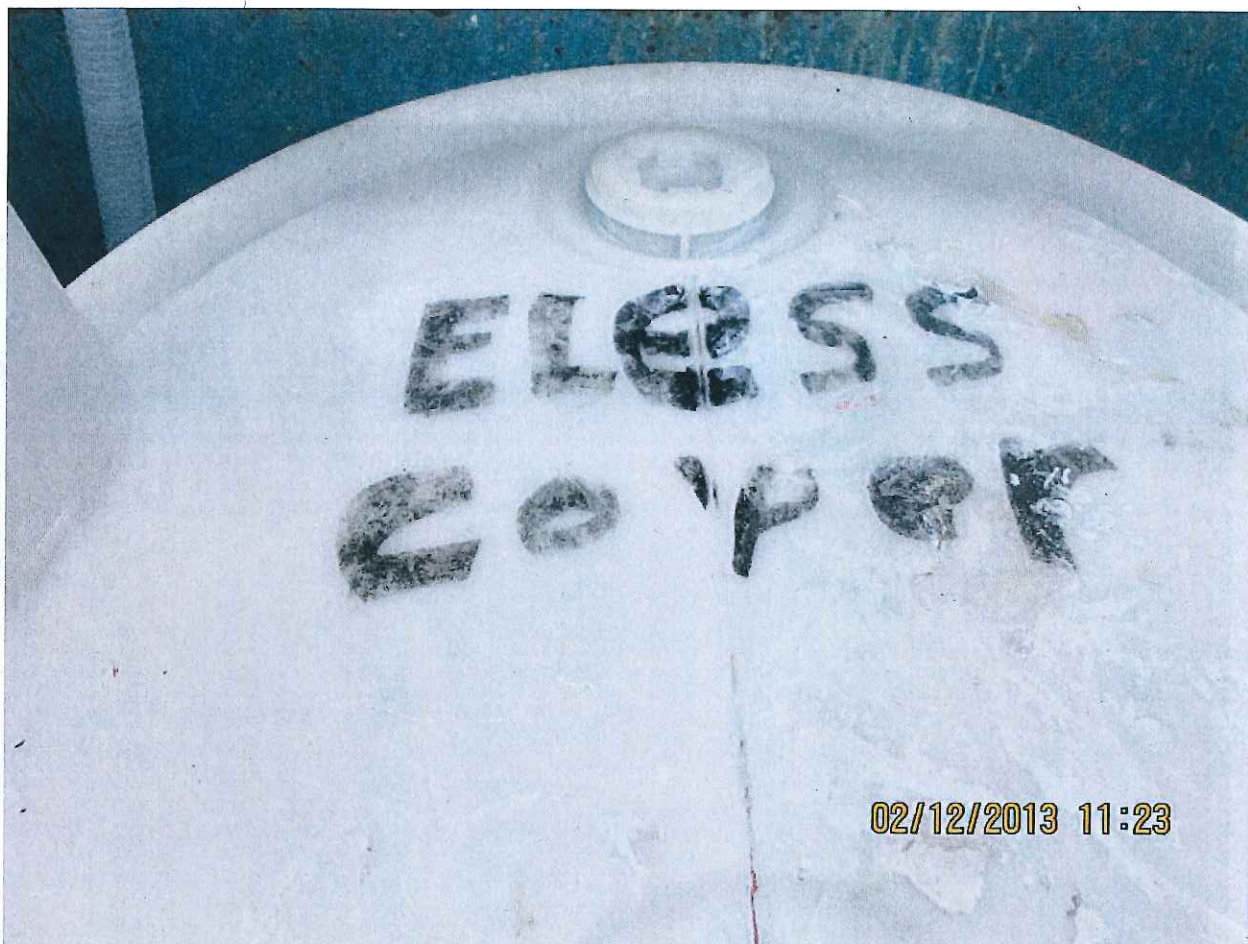
Photograph: #4

Description: A picture capturing the top of one of the plastic 55 gallon drums identified in Photo#3

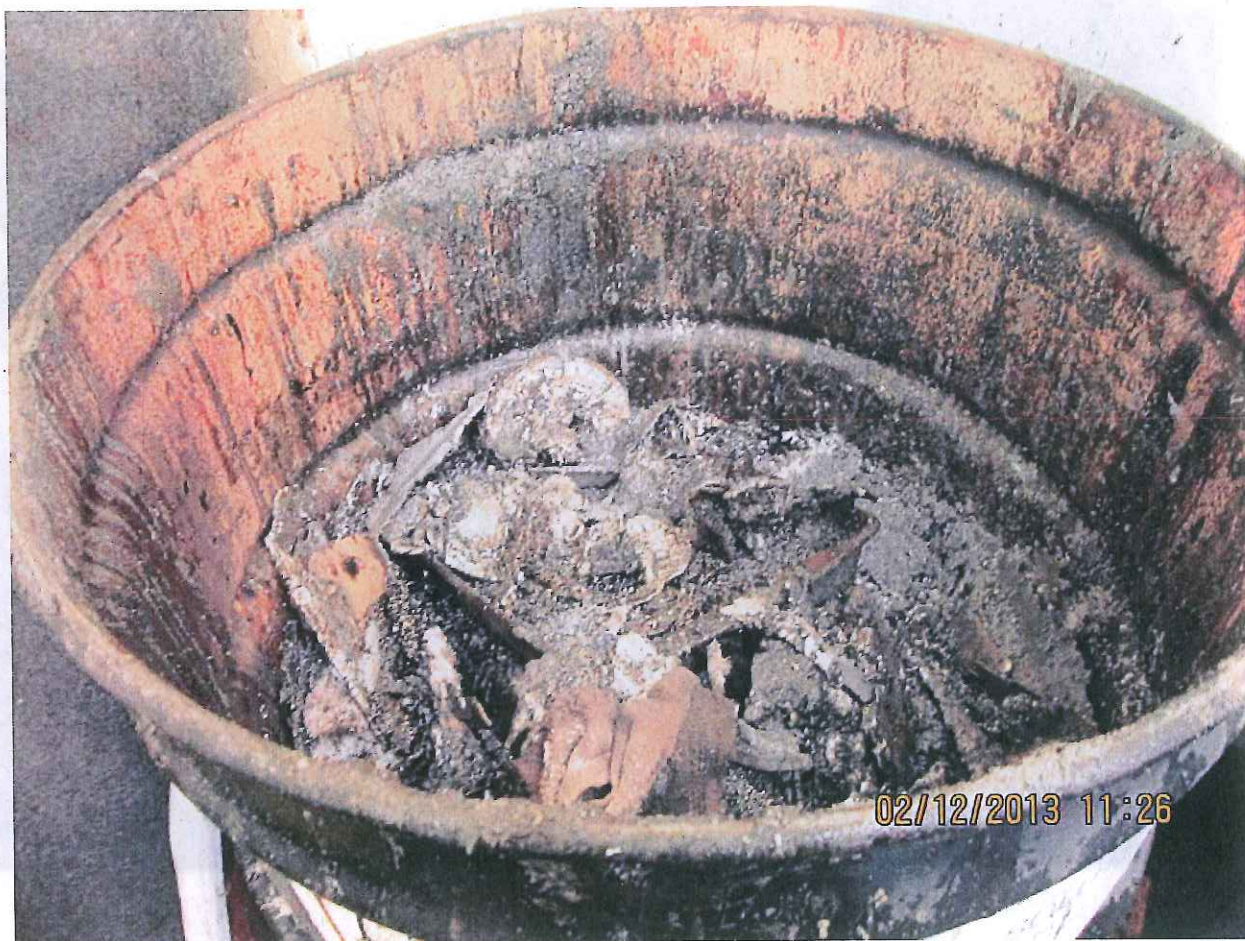
Photograph# 5

Description: Open and unmarked 55 gallon drum containing spent solder dross located in the Electrolyte Tin Processing Area

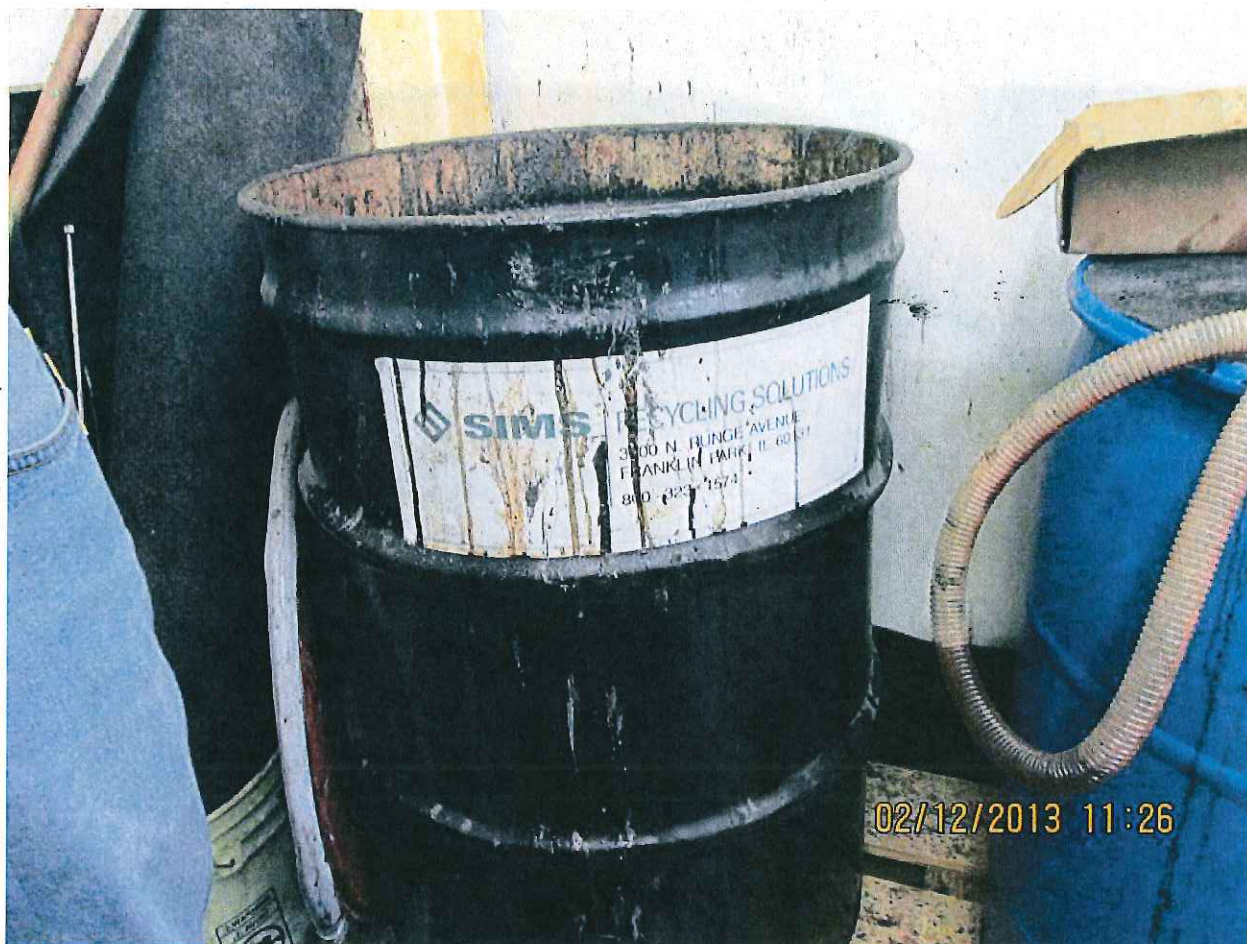
Photograph: 6#

Description: Unmarked 55 gallon drum identified in Photo#5

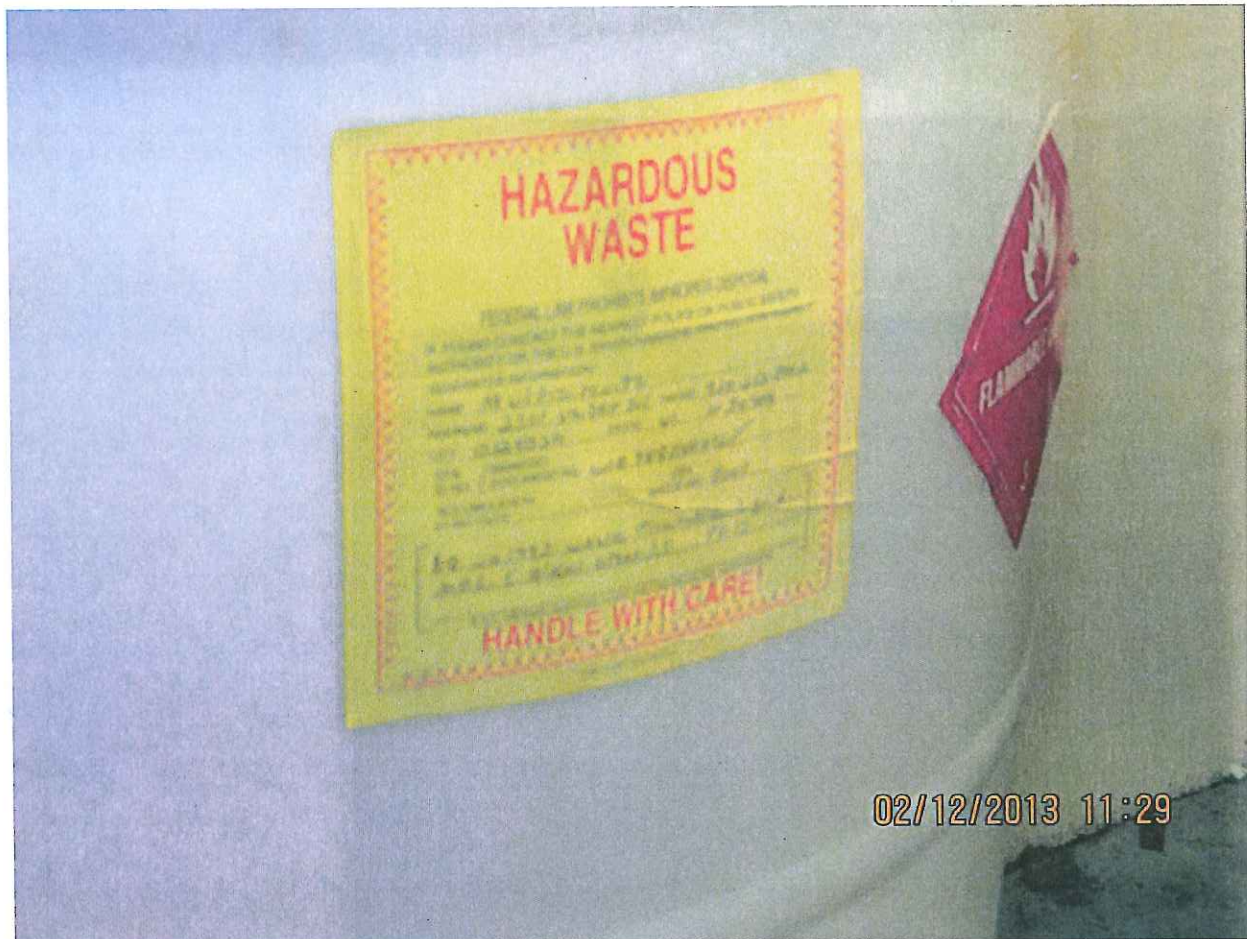
Photograph: #7

Further along in the tour, Inspector Dabner observed several opened plastic 55-gallon drums marked as hazardous waste at the Solder Mask Satellite Accumulation Area. The first 55-gallon drum was marked Gylco Ether, Waste Code D001. Pictures were taken of the opened 55-gallon drum. See Photographs#7 through 9. A cover was placed on the drum during the time of the inspection. The second 55-gallon plastic drum was observed opened with a filter inserted in the drum. This white 55-gallon drum was marked as hazardous waste to be treated, Multi-Bond Ballout. A picture was taken of the opened 55-gallon drum. See Photographs#10 through 14. During the inspection, the filter was removed and replaced with a cap to close the drum.

Description: Open plastic 55 gallon drum containing hazardous waste located at a satellite accumulation area

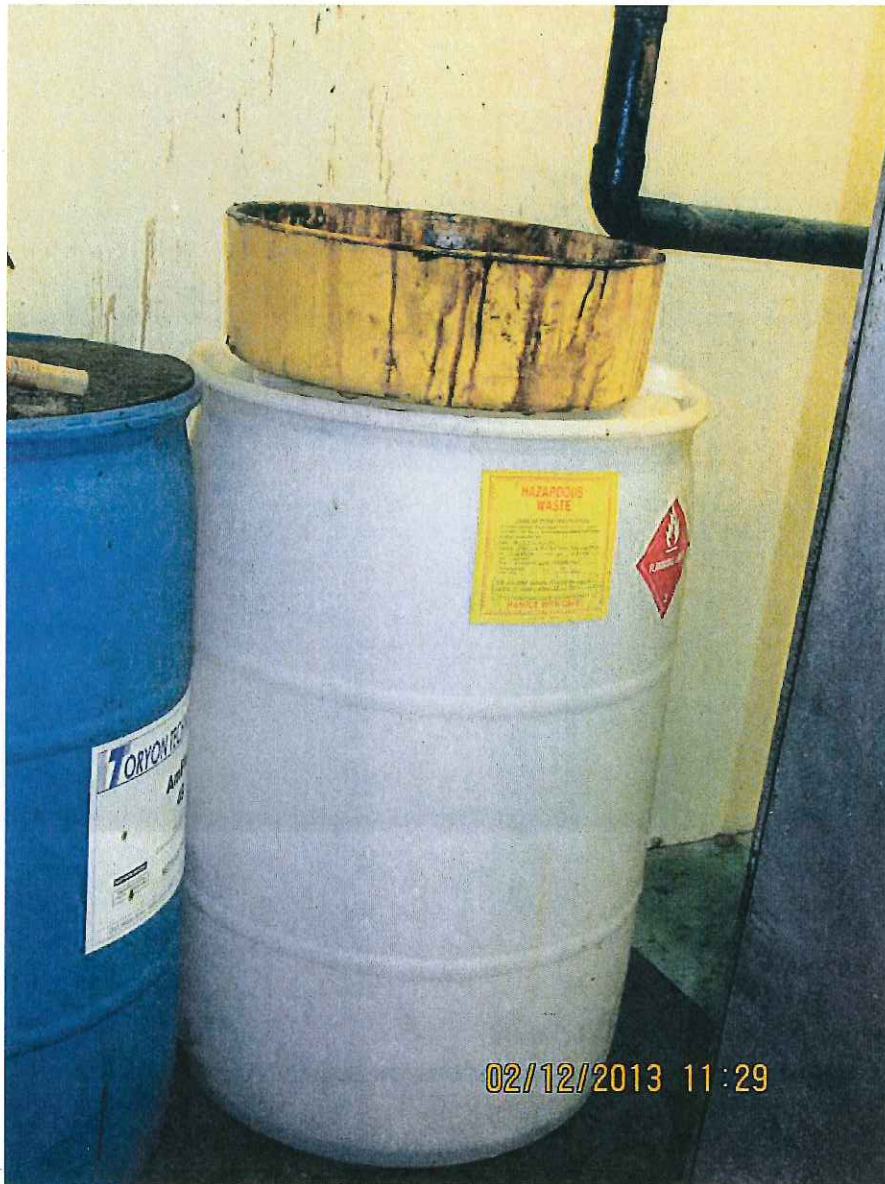
Photograph: #8  
Name of Photographer: Cindy Dabner  
Date/Time of Photograph: February 12, 2013  
Site Location: 2301 Universal Street, Oshkosh, WI 54804  
Description: Open plastic 55 gallon drum containing hazardous waste identified in Photo#7

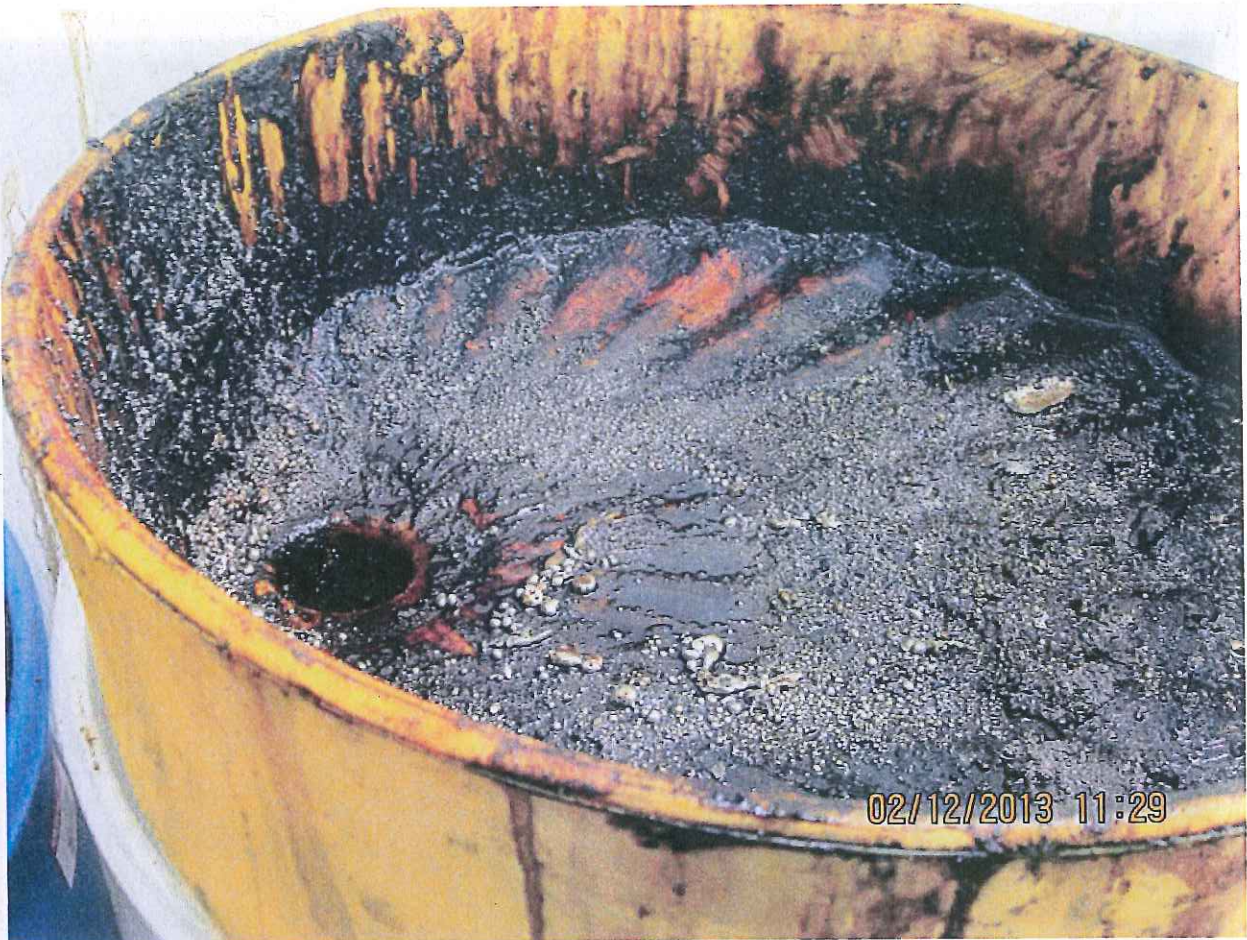
Photograph: #9

Description: Open plastic 55 gallon drum containing hazardous waste located at a satellite accumulation area

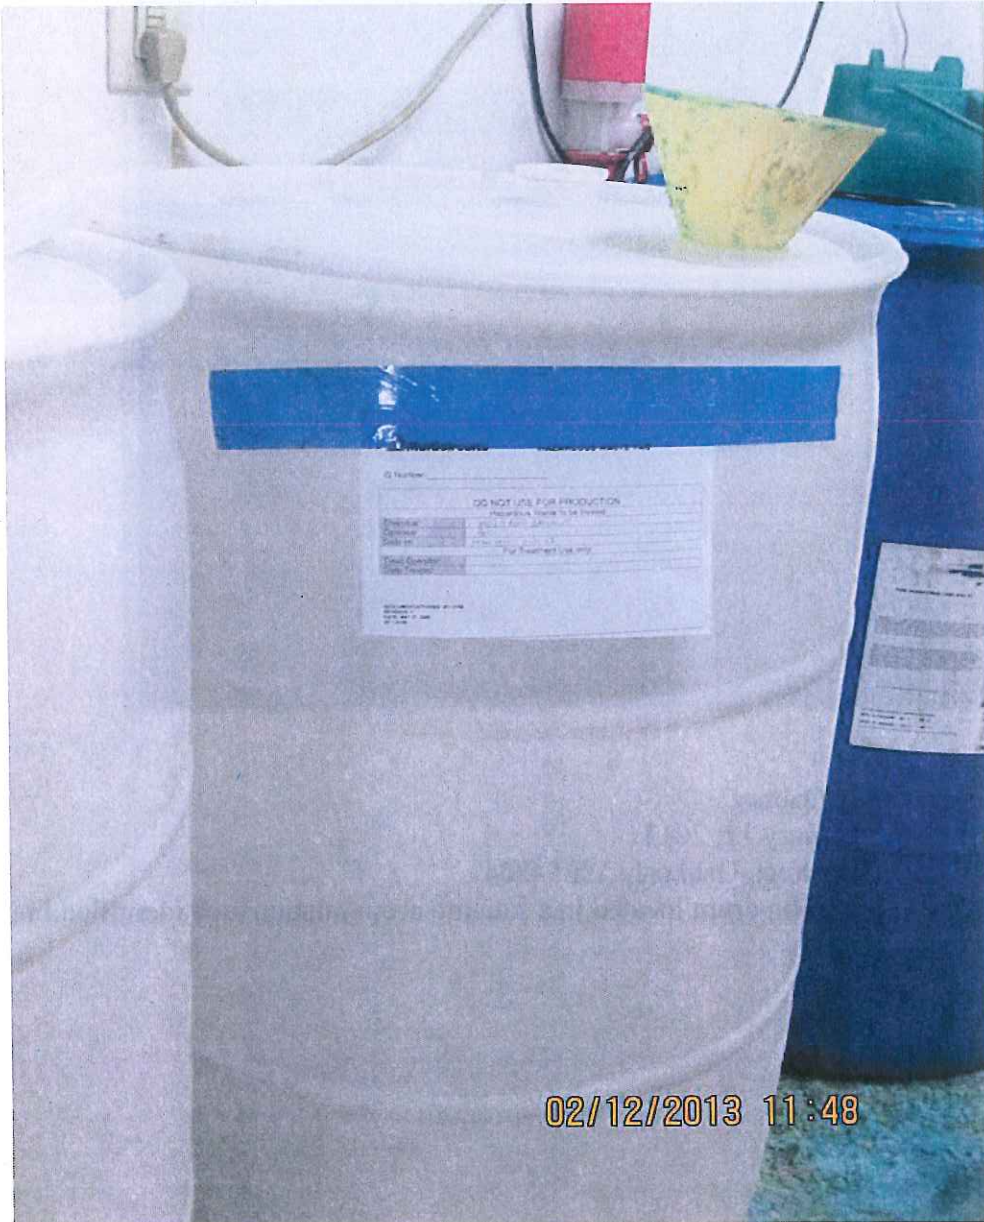
During the inspection of the satellite accumulation areas, the inspector observed four open four 55 gallon drums. Hazardous waste was not added or removed at the time of the inspection. Multicircuits, therefore, failed to comply with the above-referenced conditions for a license exemption. Facility personnel provided lids to close the 55 gallon drums and provided documentation of the closed drums on April 8, 2013. Thus, no further actions are necessary to comply with the satellite container management condition.

Photograph: 11#  
Name of Photographer: Cindy Dabner  
Date/Time of Photograph: February 12, 2013  
Site Location: 2301 Universal Street, Oshkosh, WI 54804  
Description: Open plastic 55 gallon drum located in a satellite accumulation area

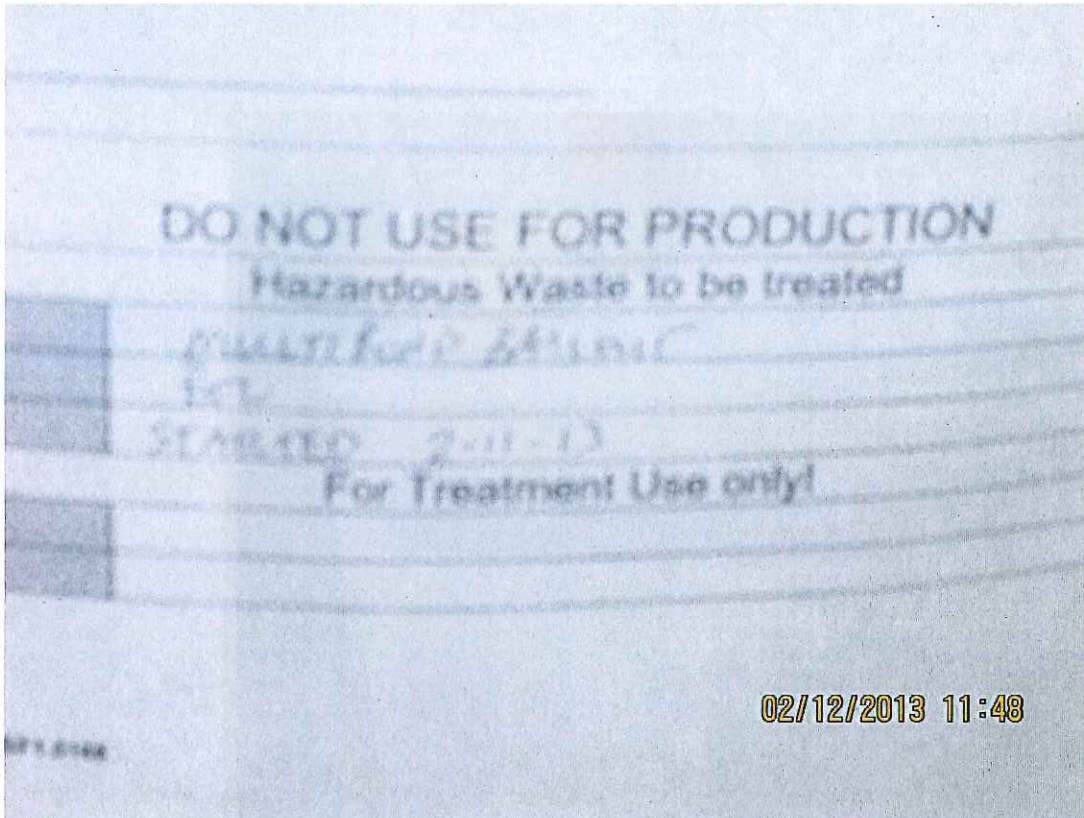
Photograph: #12

Description: Open plastic 55 gallon drum located in a satellite accumulation area identified in Photo#11

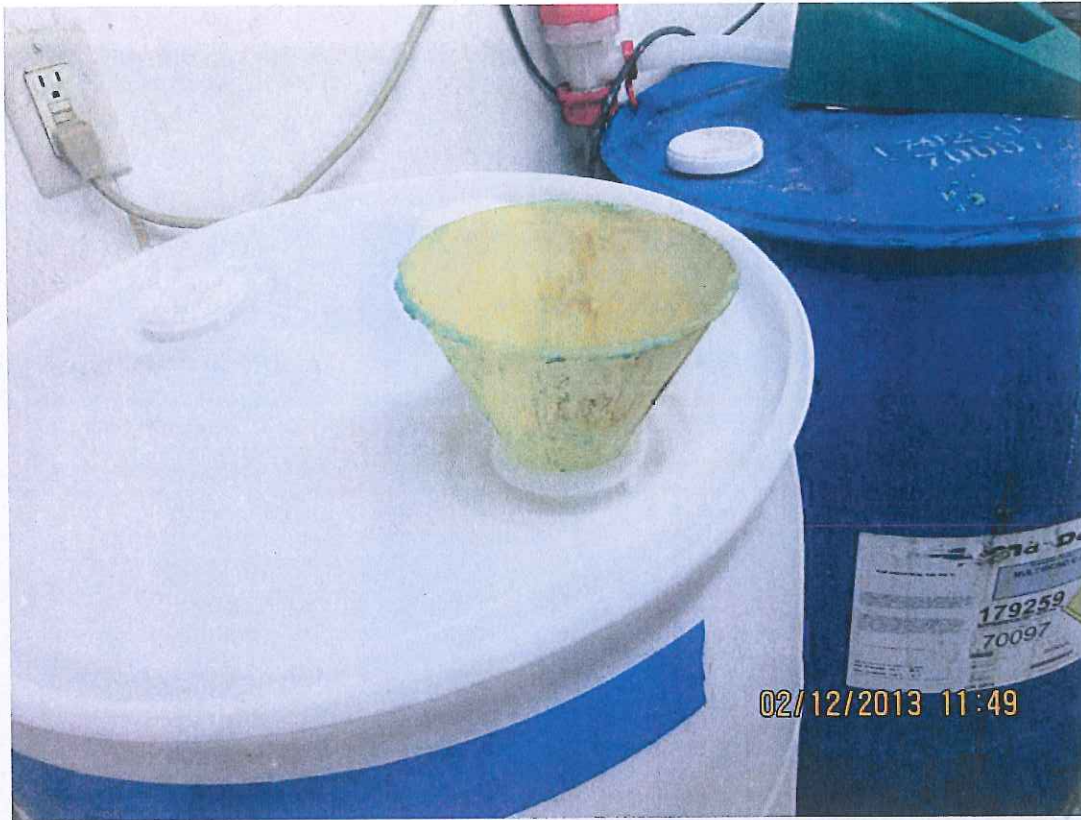
Photograph: #13

10	Open plastic 55 gallon drum located at Satellite Accumulation Area identified in Photo#11	2/12/13 11:48 am
11	Open plastic 55 gallon drum located in a Satellite Accumulation Area	2/12/13 11:48 am
12	Open plastic 55 gallon drum located in a Satellite Accumulation Area identified in Photo#11	2/12/13 11:48 am
13	Open plastic 55 gallon drum located in a Satellite Accumulation Area identified in Photo#11	2/12/13 11:49 am
14	Container marked as material for use/reuse	2/12/13 12:02 pm
15	Open 55 gallon drum containing hazardous waste located at a Satellite Accumulation Area identified in Photo#16	2/12/13 12:07 am
16	Open 55 gallon drum containing hazardous waste located at satellite accumulation are	2/12/13 12:07 pm
17	Open 55 gallon drum containing hazardous waste located at a satellite accumulation area identified in Photo#15	2/12/13 12:07 pm
18	Open 55 gallon drum containing hazardous waste located in a Satellite Accumulation Area identified in Photo#15	2/12/13 12:10 pm

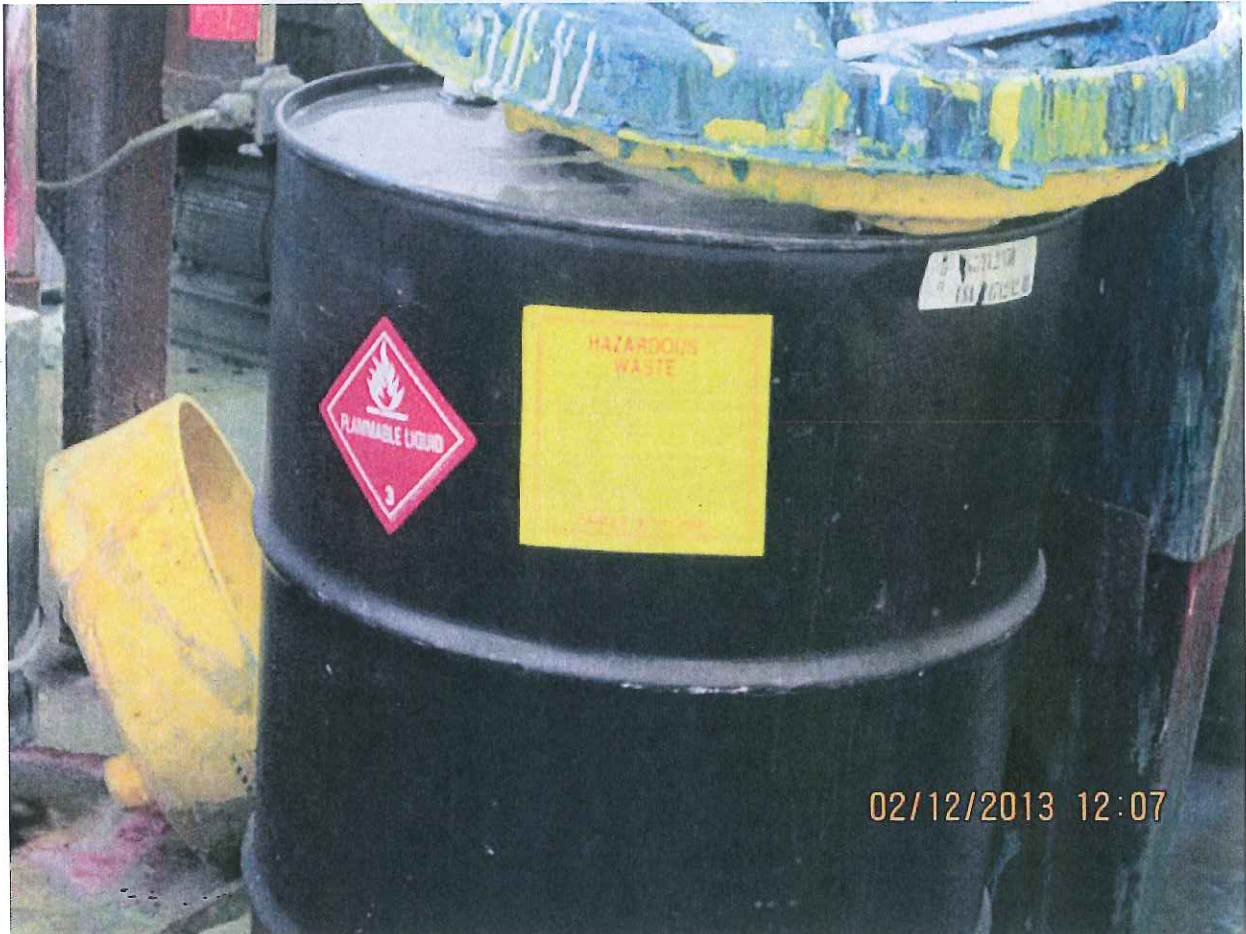
Photograph: #15

At another Solder Mask Satellite Accumulation Area, Inspector Dabner observed an uncovered 55-gallon drum marked as Waste Flammable Liquid D001, Glycol Ether. Pictures were taken of the uncovered 55-gallon drum. See Photographs #15-19. During the inspection, the filter was removed and replaced with a cap to close the drum.

Description: Open 55 gallon drum containing hazardous waste located at a satellite accumulation identified in Photo#16

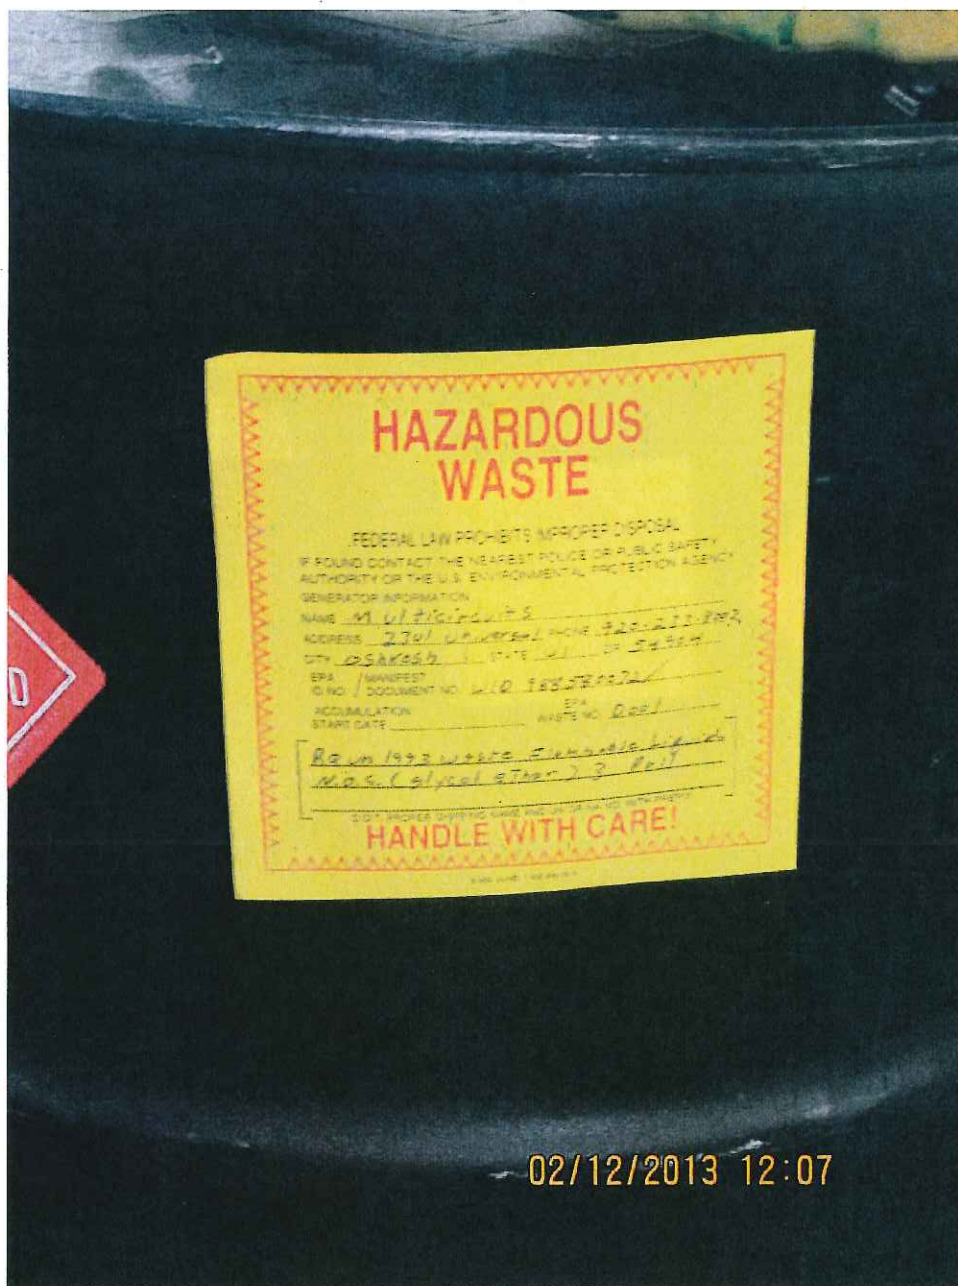
Photograph: #16

Description: Open 55 gallon drum containing hazardous waste located in a satellite accumulation area

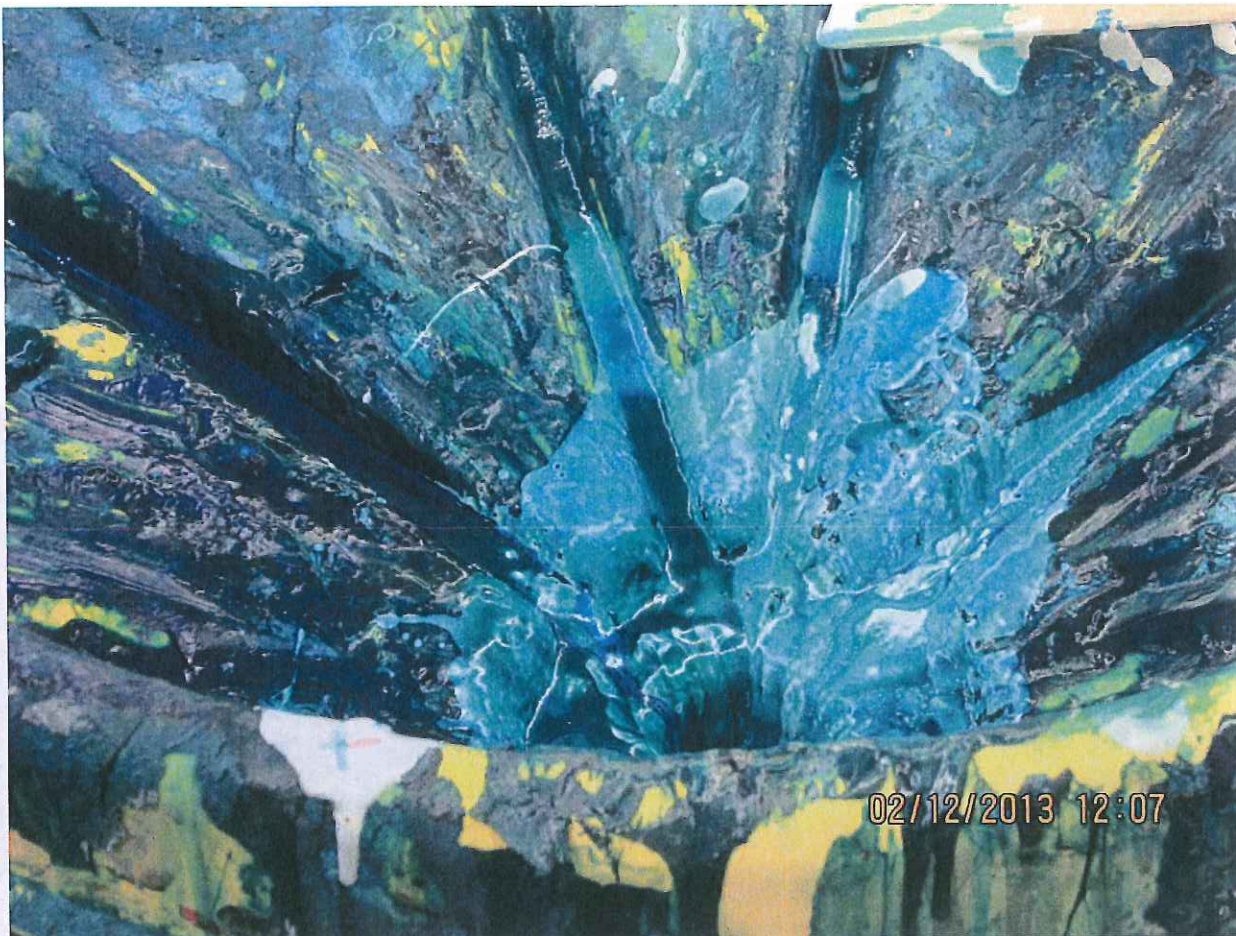
Photograph: #17

Description: Open 55 gallon drum containing hazardous waste located at a satellite accumulation area identified in Photo#16

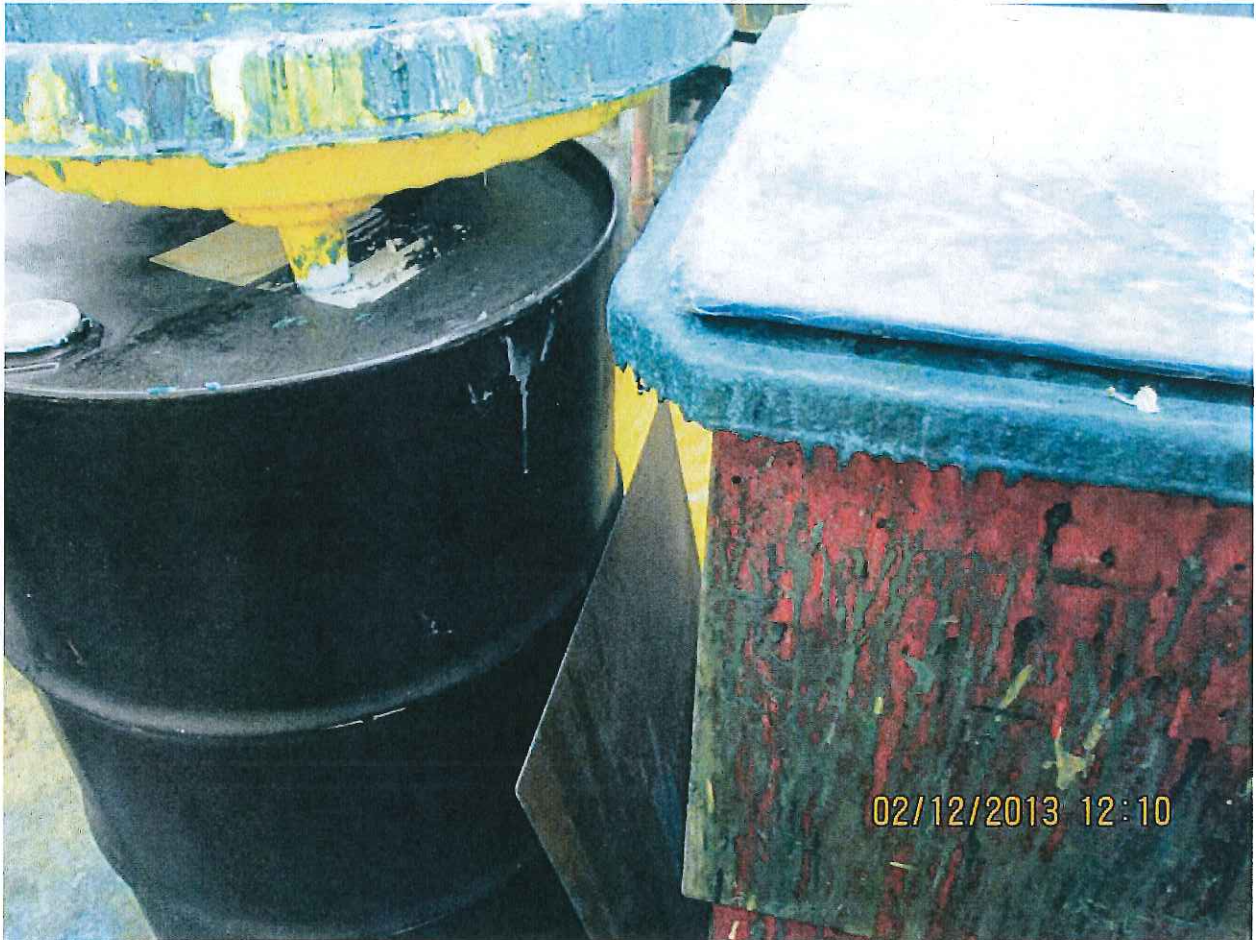
Photograph: #18

Description: Open 55 gallon drum containing hazardous waste located in a satellite accumulation area identified in Photo#17

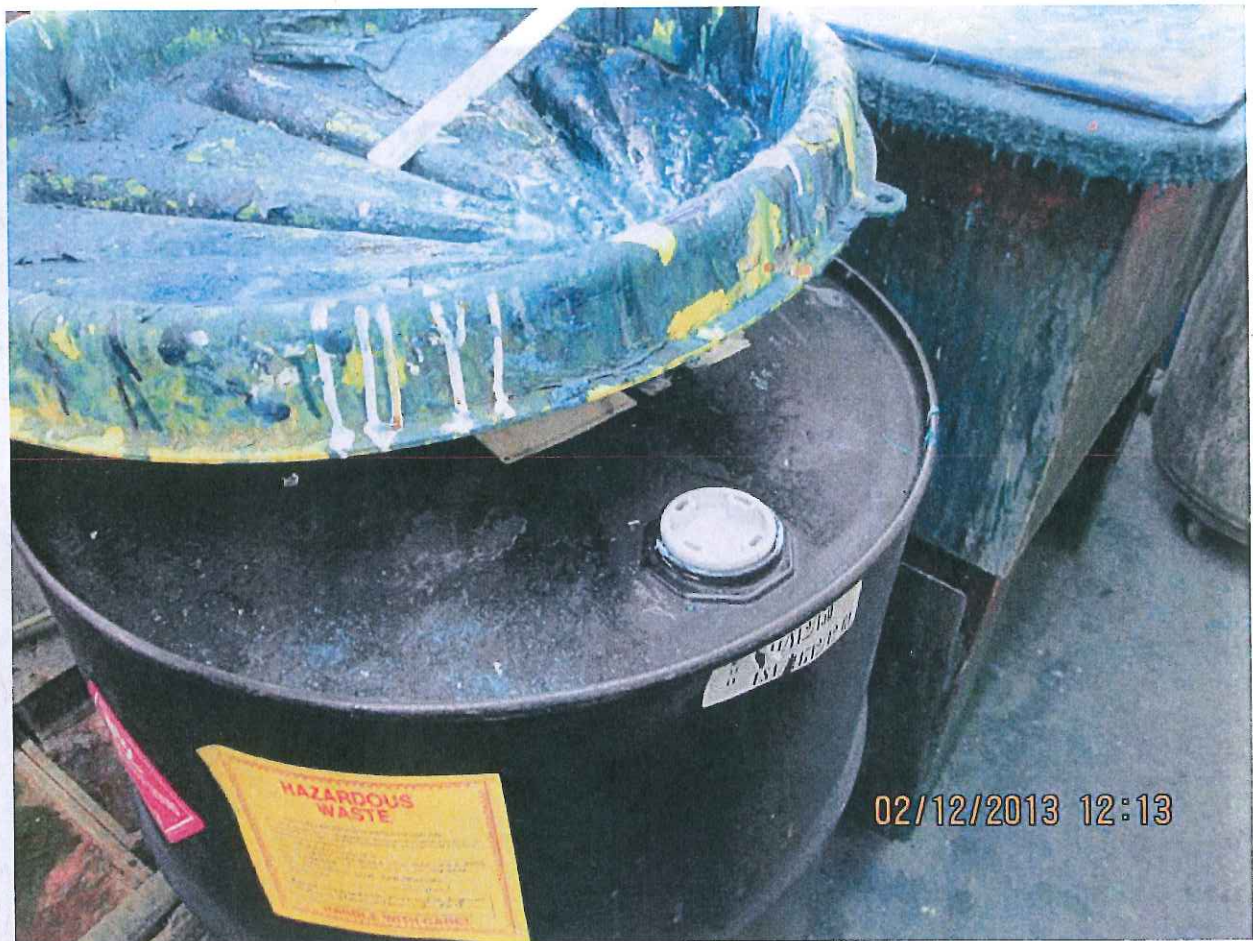
Photograph: #19

Description: Open 55 gallon drum container hazardous waste located at a satellite accumulation area identified in Photo#18

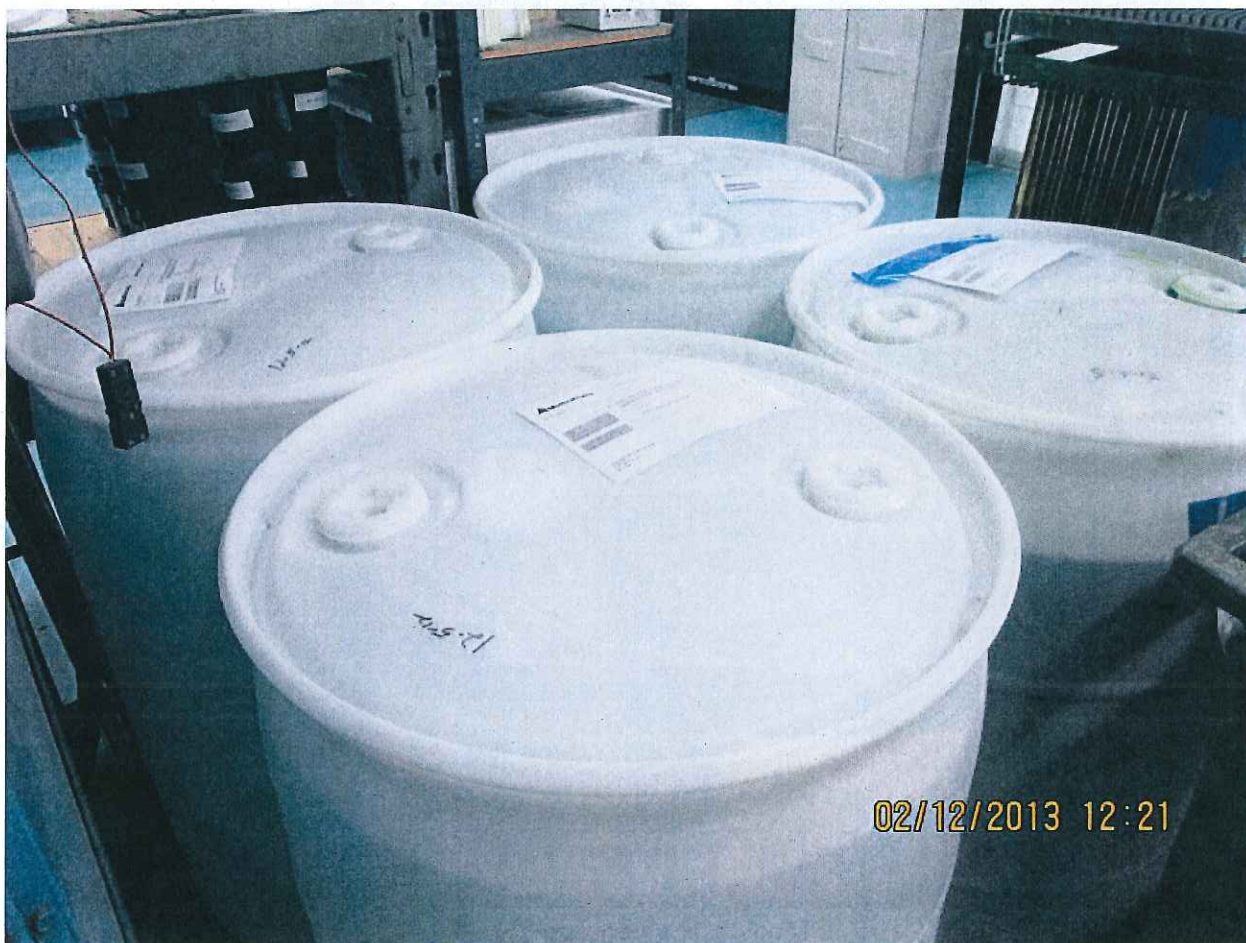
Photograph: #20

During the inspection of the 90 day accumulation area, the inspector observed four 55 gallon drums marked with two accumulation start dates. The marking of two dates on each of the four drums did not clearly identify the date upon which the accumulation began. Multicircuits, therefore, failed to comply with the above-referenced condition for a license exemption and violated the above-referenced storage container management requirement. However, Multicircuits, submitted documentation on April 8, 2013

The inspection moved to the 90-Day Accumulation Area. Four drums were stored at the 90-Day Accumulation Area. Mr. Kemper informed Inspector Dabner that waste is stored at this location prior to going to the wastewater treatment system. Four 55-gallon drums were observed to have two dates. Drum#1 was marked 5 Percent Acid and was dated 2/8. Drum#1 was also dated 12/5/12. Drum#2 was marked 5 Percent Acid and dated 2/8. Drum#2 was also dated 8/3/12. Drum#3 was marked Multi-Bond Ballout and was dated 2/11/13. Drum#3 was also dated 12/5/12. Drum#4 was marked 10 Percent Acid and dated 2/8. Drum#4 was also dated 12/5/12. Pictures were taken to show the two dates on the drums. See Photograph#20 through 28.

Description: Four plastic 55 gallon drums located in the 90 day accumulation storage area

showing corrections made to container management at the facility. Thus, no further actions are necessary to comply with the above-referenced condition.

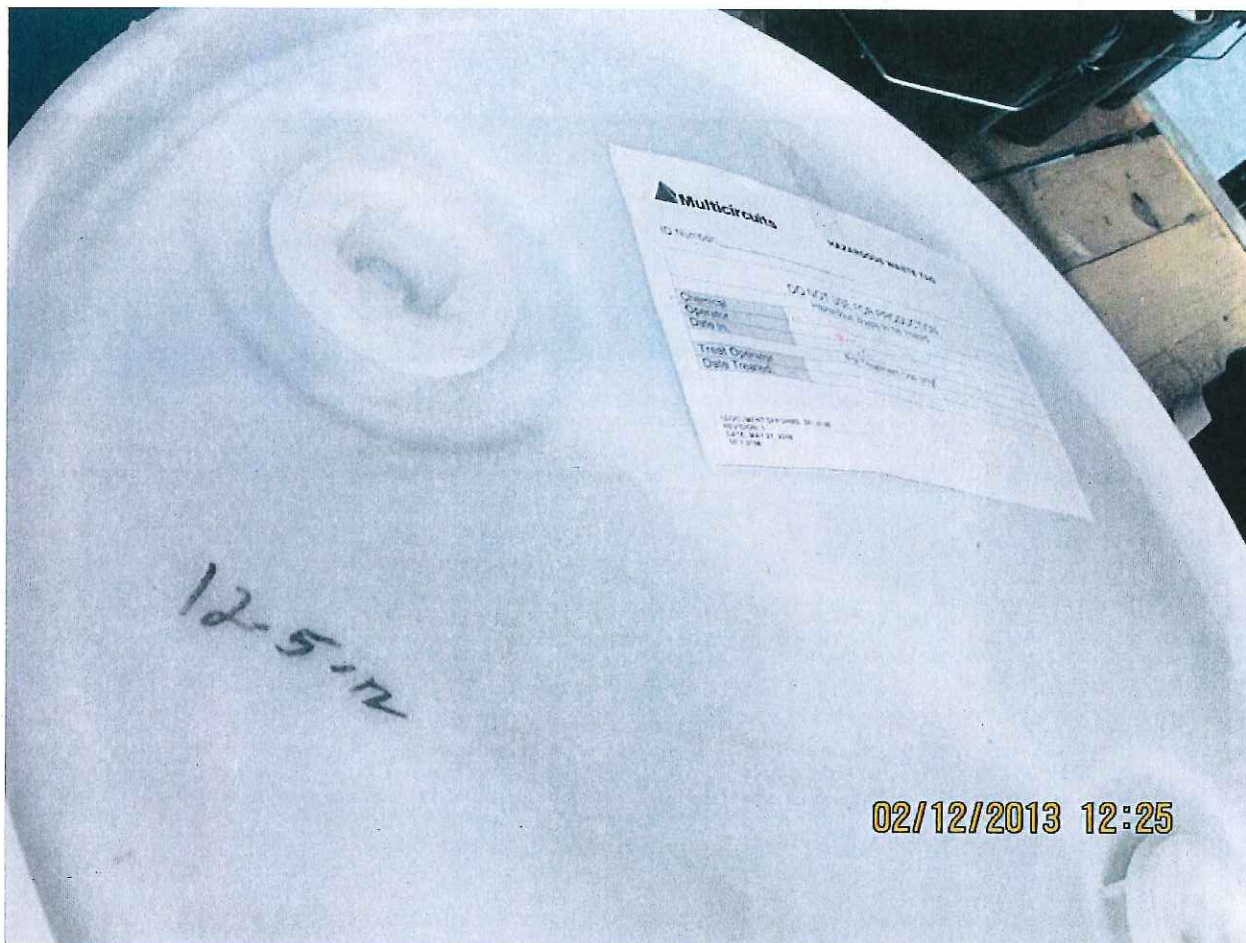
Photograph: #26

Description: A plastic 55 gallon drum marked with two dates located in the 90 day storage area
